Conceptual Master Plans for the Brackenridge Tract

PROJECT REPORT - APPENDICES

APPENDIX A. Existing Conditions

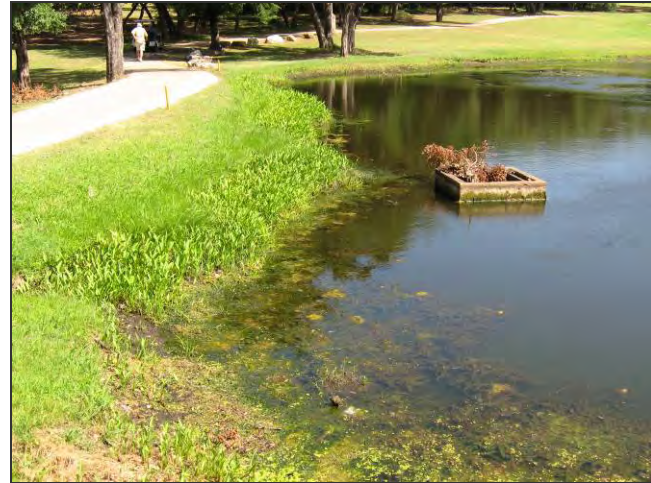
Fringe Wetland Vegetation
(Golf Course Tract)

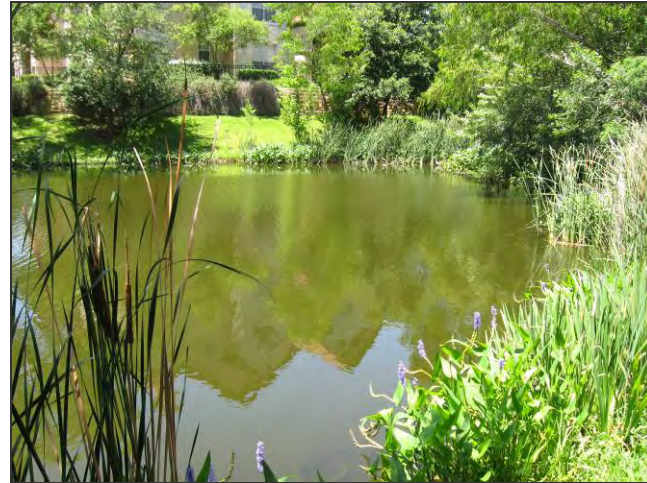
Wetland Vegetation
(Deep Eddy Tract)

Potential canyon rim rock, springs and wetlands are noted in the RKCI data tables. It is anticipated that further field observation and research is necessary to determine whether these features qualify as critical environmental features under the City definition, and

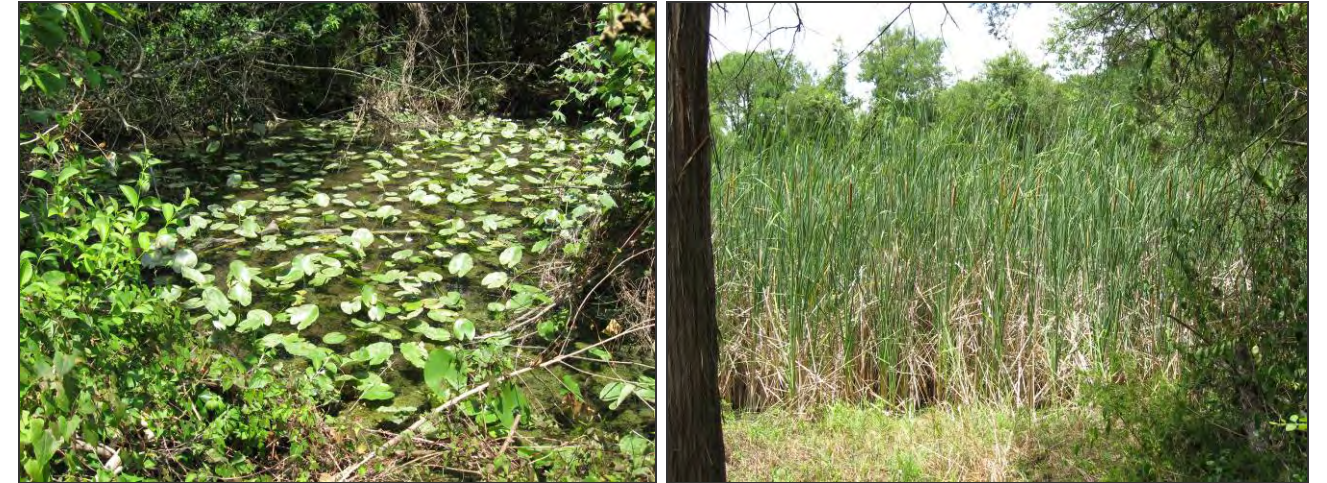
Wetlands
(Brackenridge Field Laboratory)

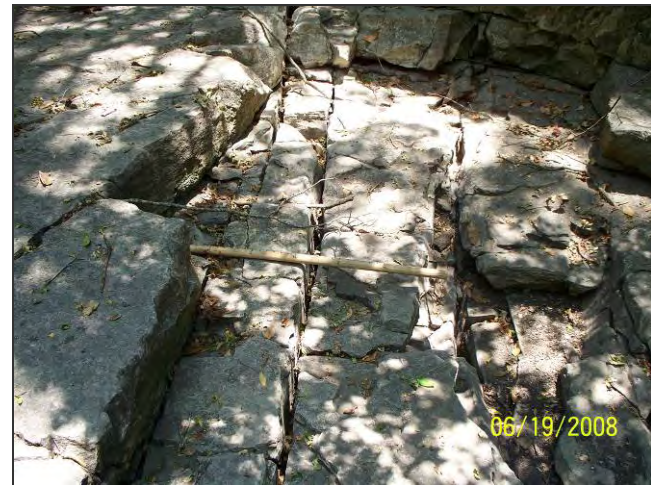
Fracture Zone
(Brackenridge Field Laboratory)

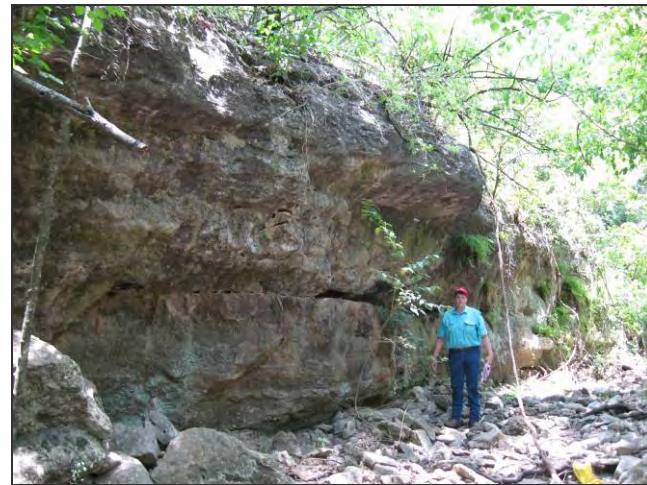
Rimrock – Former Quarry Area
(Brackenridge Field Laboratory)

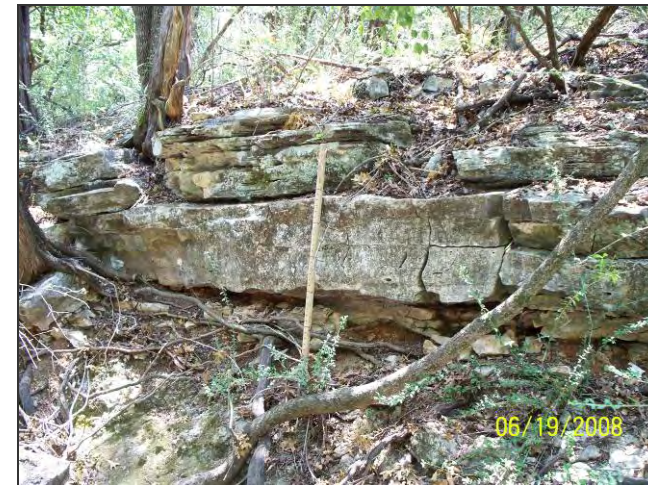
Spring-fed Pool in Unnamed Creek
(Brackenridge Field Laboratory)

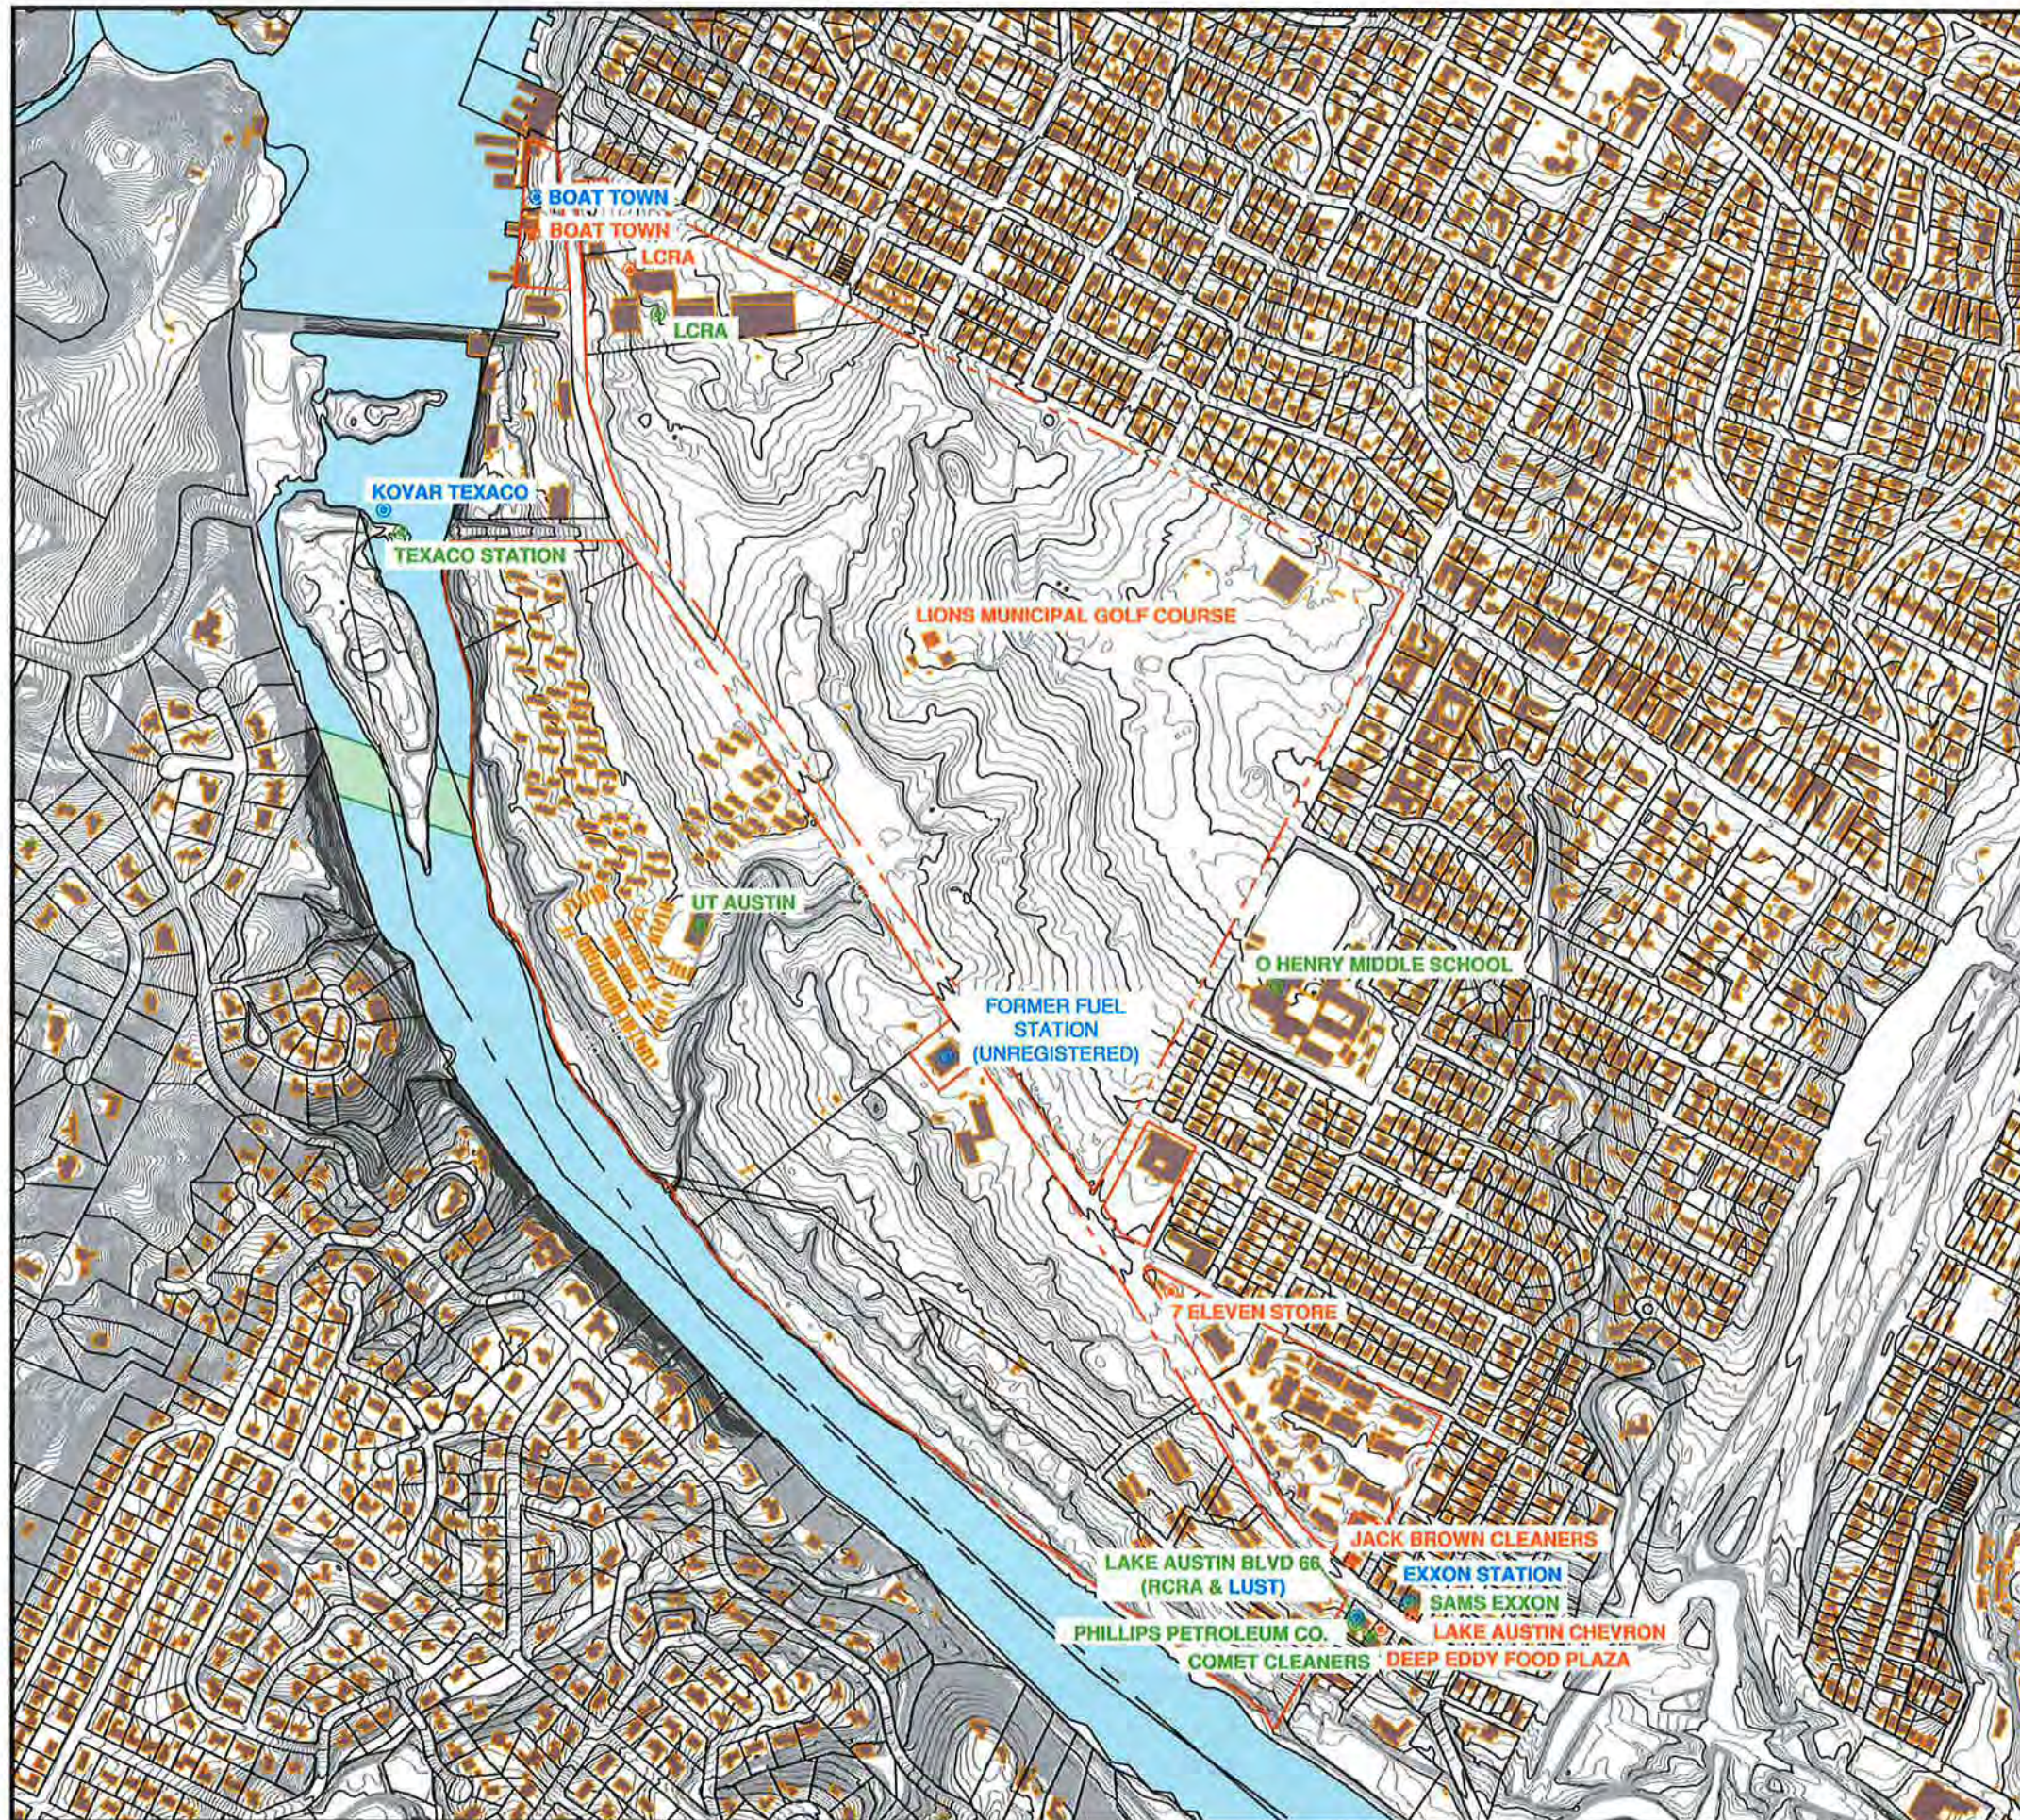
FIGURE
4

- SITE BOUNDARY
- REGISTERED UNDERGROUND STORAGE TANK
- LEAKING UNDERGROUND STORAGE TANK (LUST)
- RCRA-GENERATOR (RCRA)

A potential leaking underground storage tank exists at the boat dock. Further review of records and potential field sampling should be accomplished to determine if remedial action is required before development plans are finalized.
